REPORT NO.
UCB/EERC-97/13
DECEMBER 1997
59A131

FATIGUE LIFE EVALUATION OF CHANGEABLE MESSAGE SIGN STRUCTURES

VOLUME 2: RETROFITTED SPECIMENS

Report to the California Department of Transportation
for Research under Contract RTA-59A131

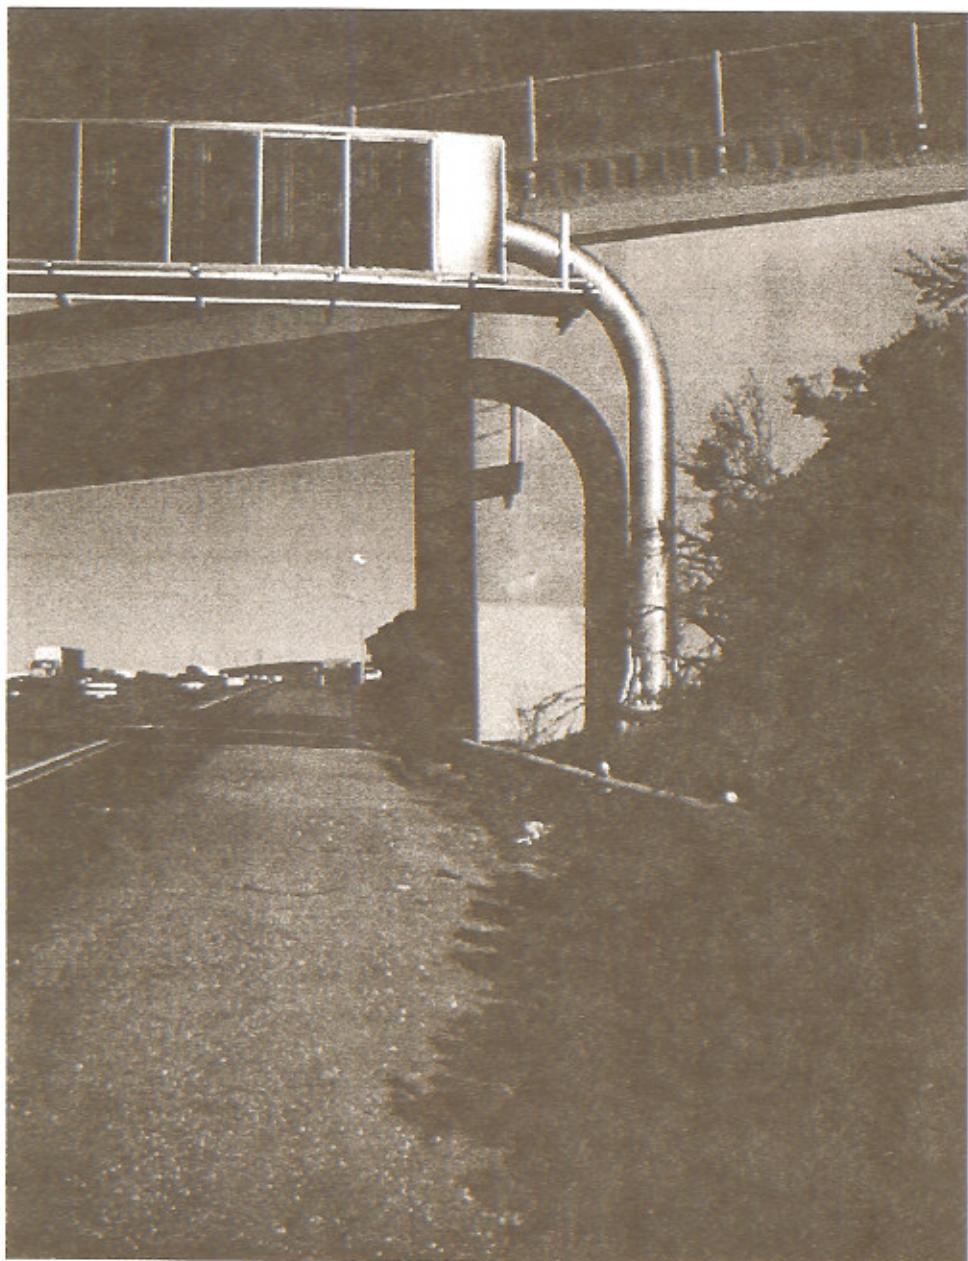
Figure 1.1: Photograph of gusset retrofitted CMS structure on Interstate 80

Changeable Message Sign (CMS) structures are widely used in California by the California Department of Transportation (Caltrans) for communicating information on road conditions to the driving public. Figure 1.1 shows a newly installed gusset-retrofitted CMS structure on Interstate 80, near Rodeo California. In the field, the CMS structures are subjected to variable environmental and wind-vibration conditions. They are designed by Caltrans using the AASHTO Standard Specifications for Structural Supports for Highway Signs, Luminaries, and Traffic Signals (AASHTO, 1994).

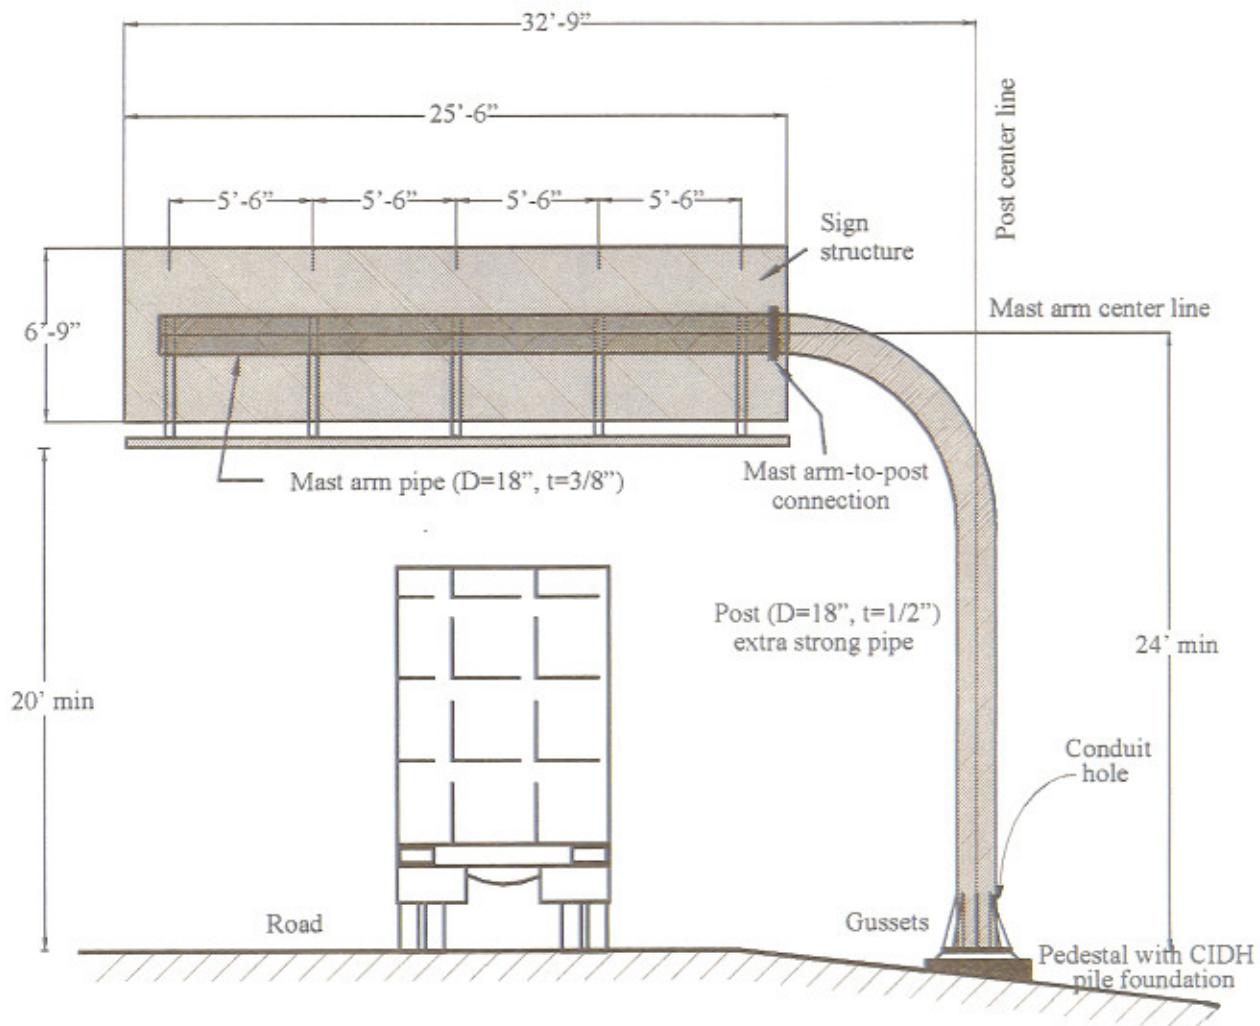
Figure 1.2: Steel-gusset retrofitted Model 500 CMS structure

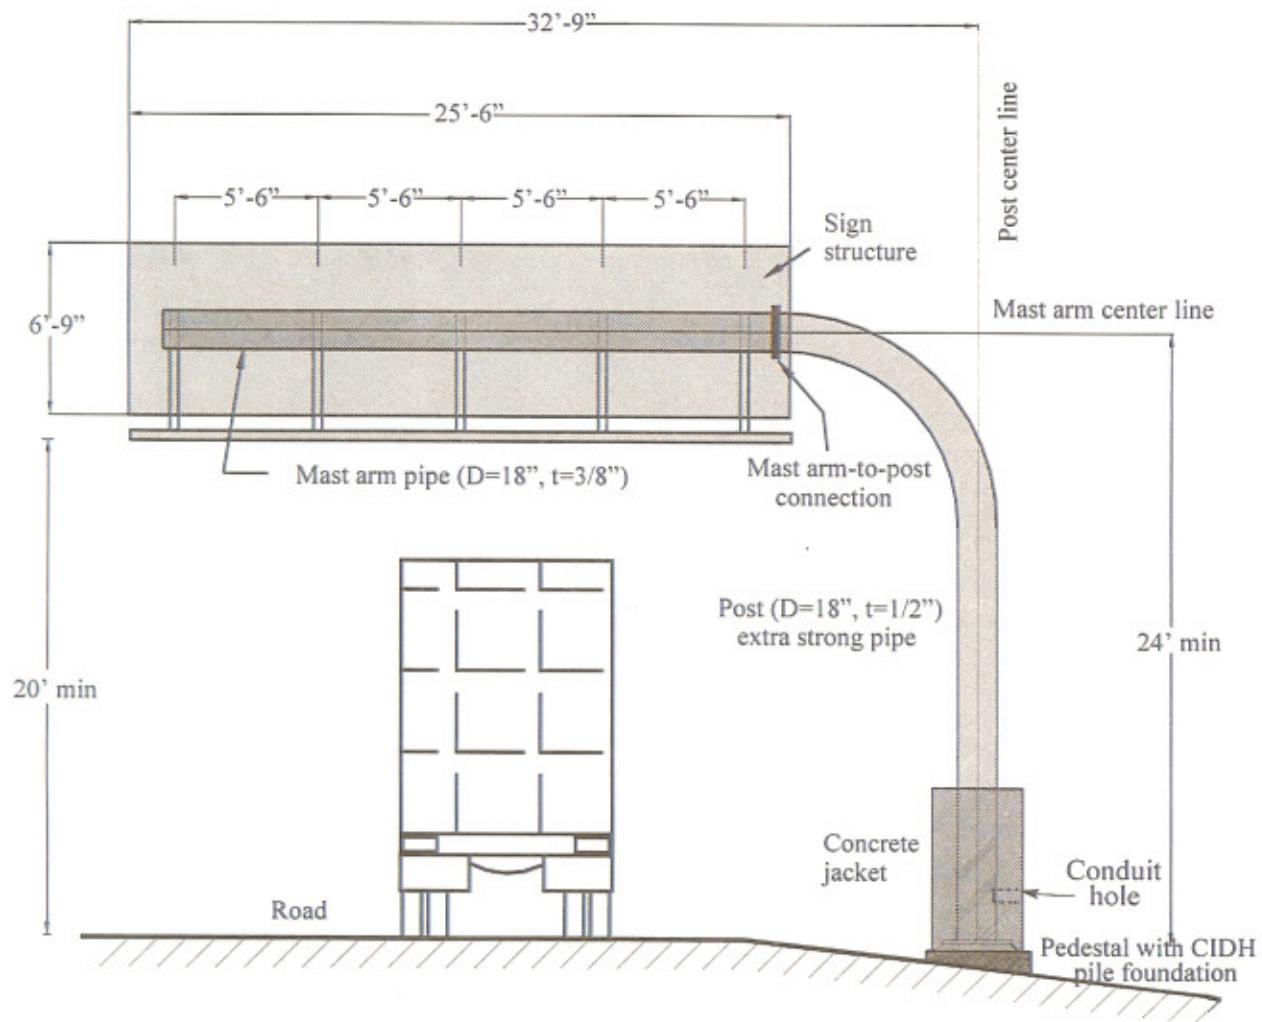
Figure 1.3: Concrete-jacket retrofitted Model 500 CMS structure

The concrete jacket retrofit detail consisted of adding a reinforced concrete shell to the steel post. The jacket had a outside diameter of 42 in. (1.1 m) and was 6 ft (1.8 m) tall. The jacket was attached to the existing foundation by drilling and bonding a total of 16 #7 vertical reinforcement bars. The transverse reinforcement in the jacket consisted of #4 hoops with a 15 in. (381 mm) lap placed at 4 in. (102 mm) spacing. Trim reinforcement was added around the conduit hole. Figure 1.3 shows the dimensions of a concrete jacket retrofitted Model 500 CMS structure. The lower 15 ft (4.6 m) of a concrete jacket retrofitted CMS was tested at EERC; refer to Chapter 5 for details.

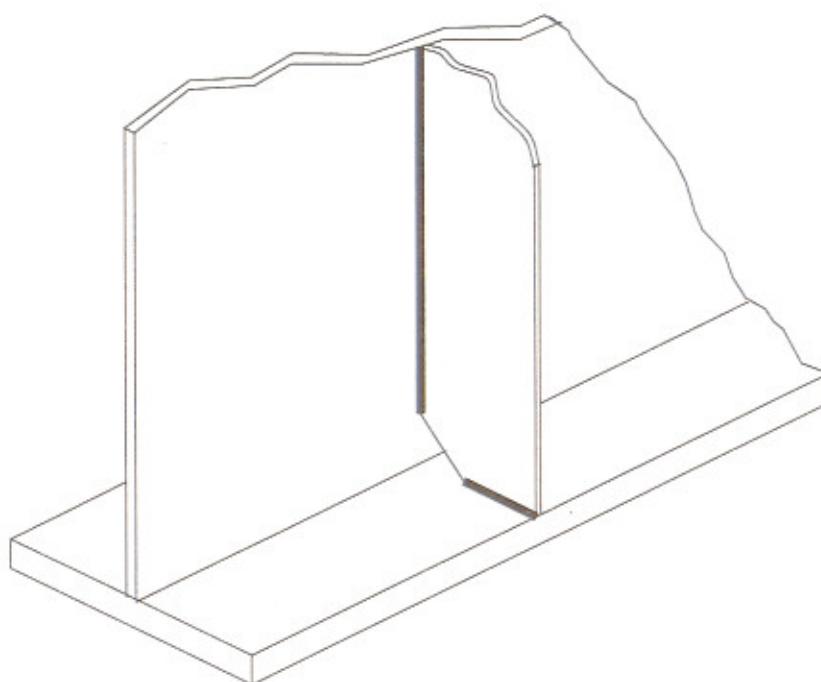
Figure 2.1: Gusset welded connection details (adapted from Daniels and Herbein, 1980)

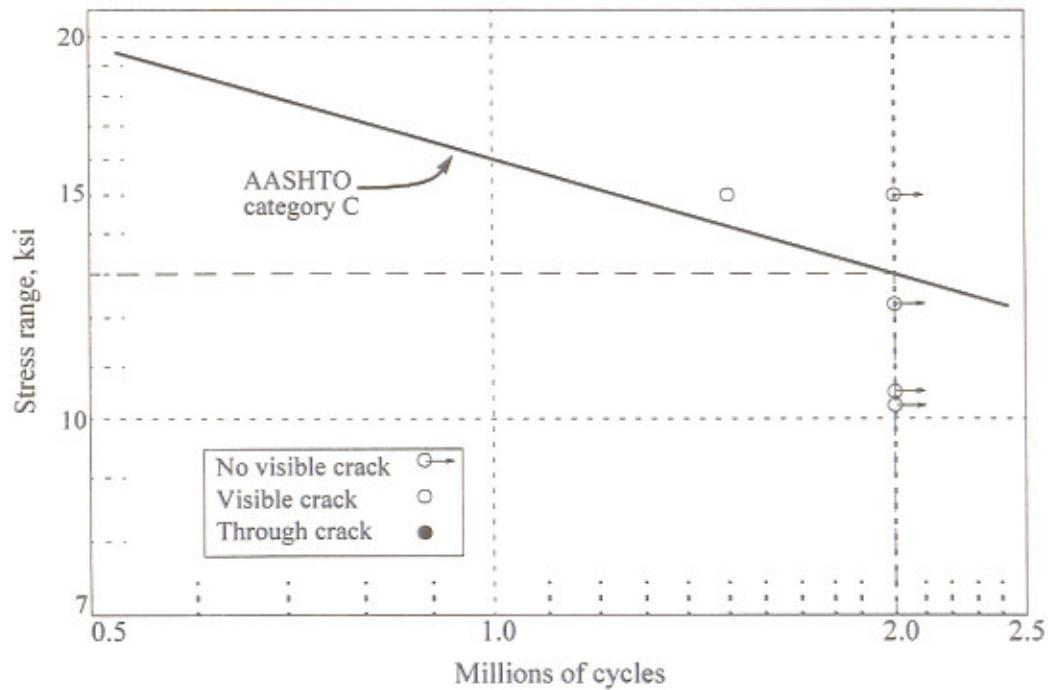
Figure 2.2: S-N curve for a gusseted connection (adapted from Daniels and Herbein, 1980)

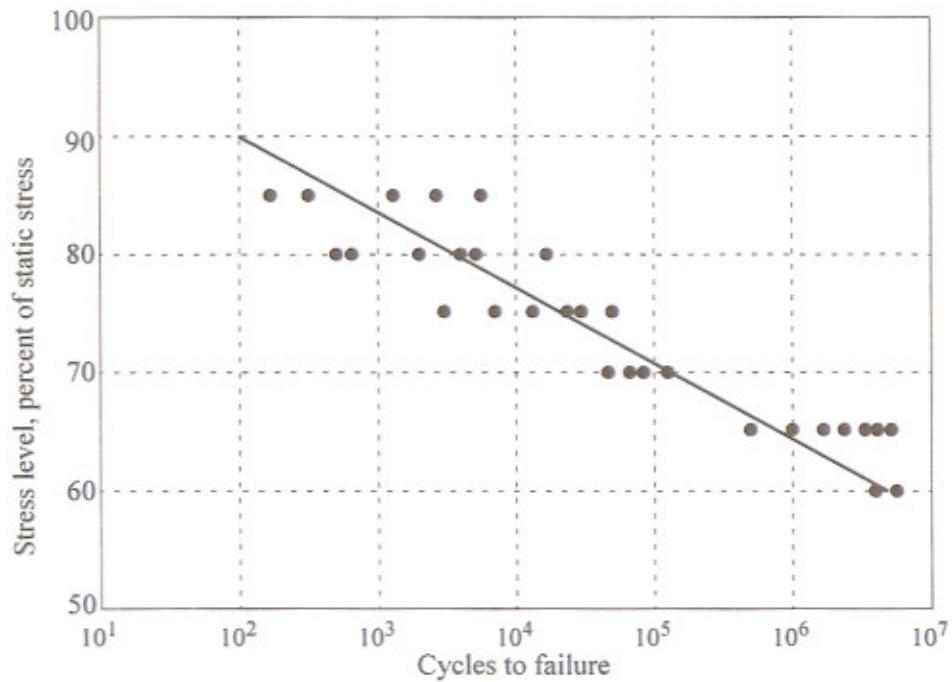
Figure 2.3: S-N curve for plain concrete (adapted from Bury and Domone, 1974)

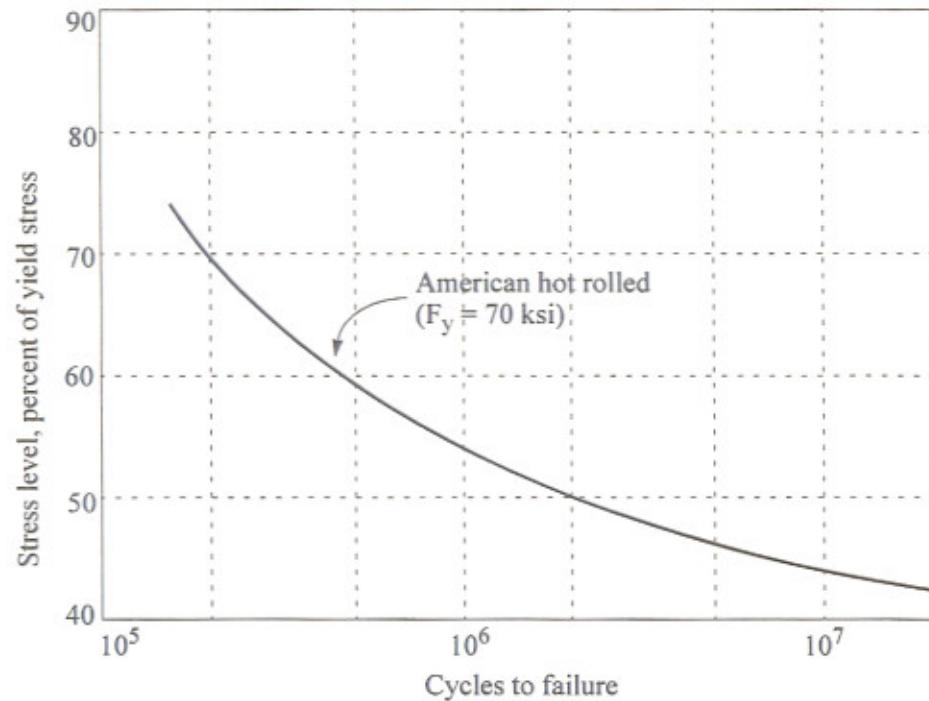
Figure 2.4: S-N curve for various reinforcing bars (adapted from Bury and Domone, 1974)

The fatigue strength of reinforcing bars under either uniaxial loading or flexural loading in reinforced concrete beams has been studied by several authors (e.g., Bury and Domone, 1974). The findings indicate that the fatigue life of reinforcing bars depends on minimum stress level, bar size, geometry of deformation, yield strength, prior bending of the bar, and welding. As is typical for metals, the fatigue life of reinforcing steel is determined by the stress range and not the absolute values of minimum and maximum applied stresses. Figure 2.4 shows a typical S-N curve of reinforcing steel bars.

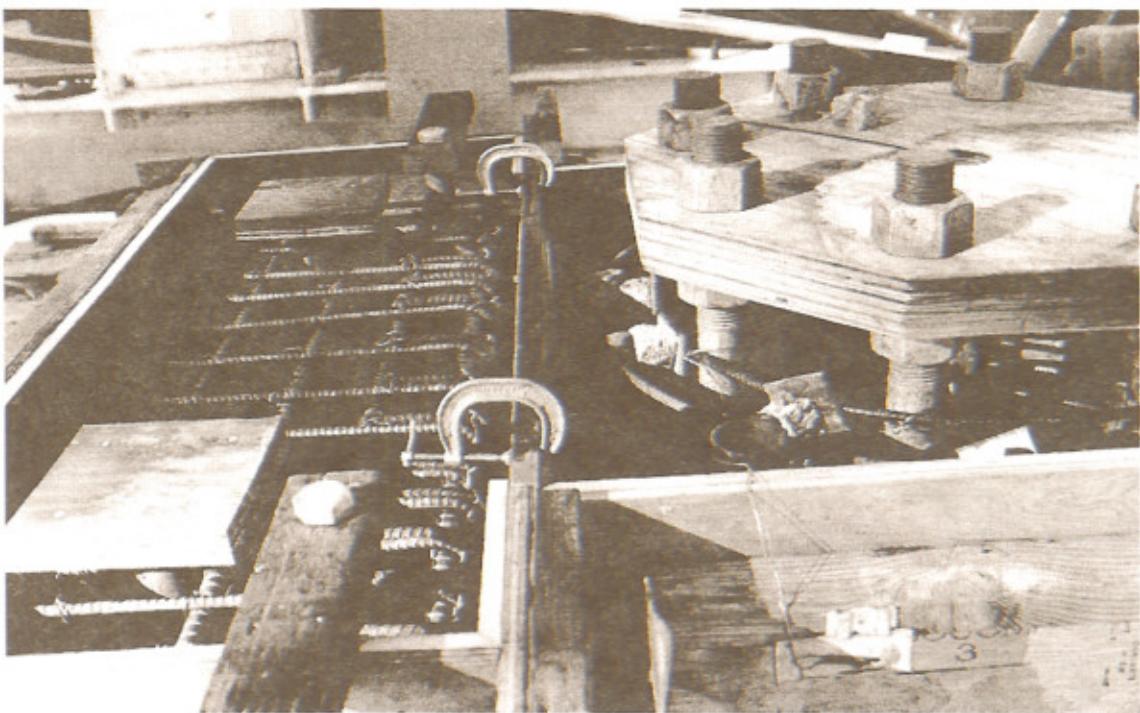
Figure 3.1: Foundation details for Specimen CIP1

A reinforced concrete foundation blocks were cast and anchored to the strong floor in the Structures Research Laboratory at EERC. The concrete foundation simulated the CIDH pile typically used as the foundation for 18 in. (46 mm) diameter CMS structures. As shown in Figure 3.1, specially fabricated anchor bolts, identical to bolts used in the field, were embedded in the foundation. The test specimens were attached to the foundation using these anchor bolts. Each specimen was leveled using nuts placed underneath the base plate. The anchor bolts at the base plate were initially snug tightened and then tightened further using the turn-of-the-nut method (AISC, 1995). The gap between the base plate and the foundation was then grouted with mortar cement.

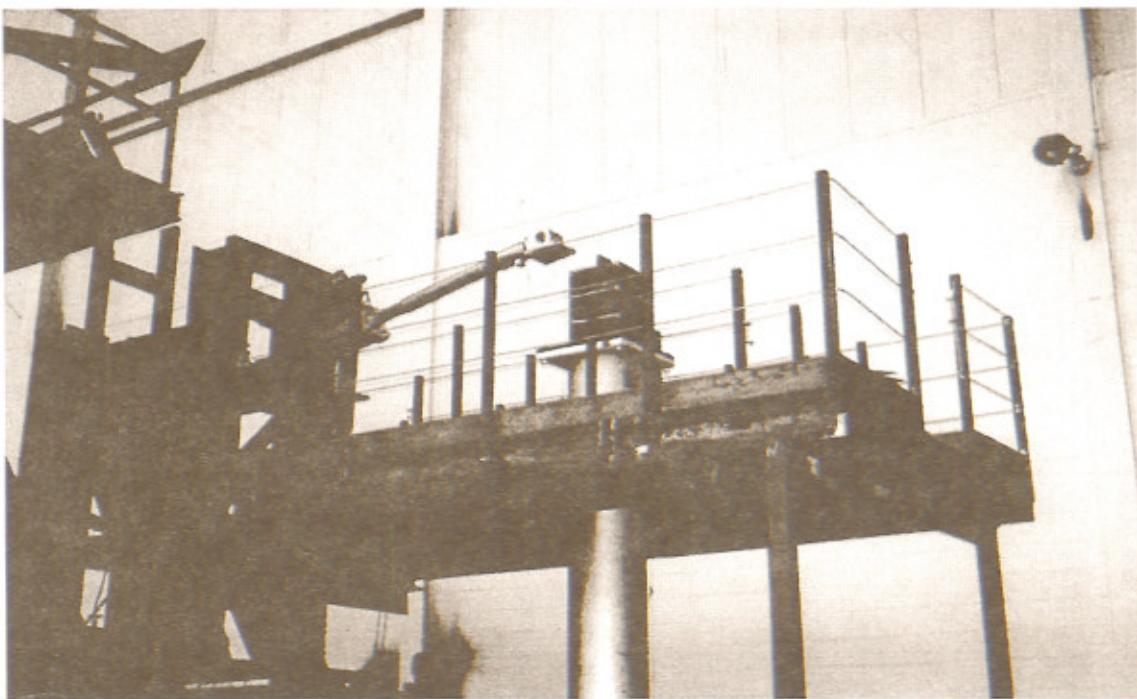
Figure 3.2: Test setup for Specimen GR1

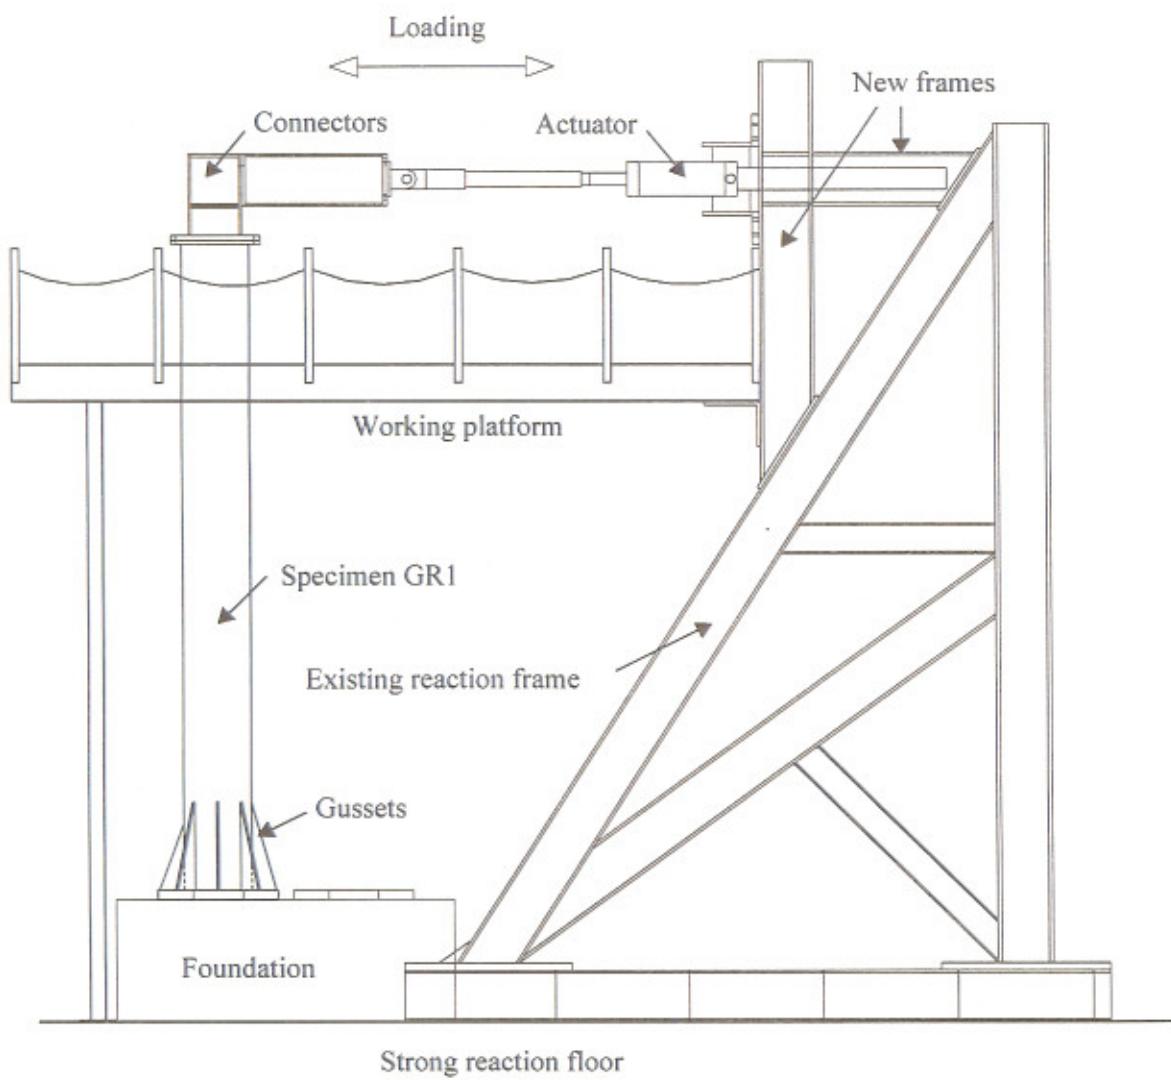
Figure 3.3: Main components of the test setup for Specimen GR1

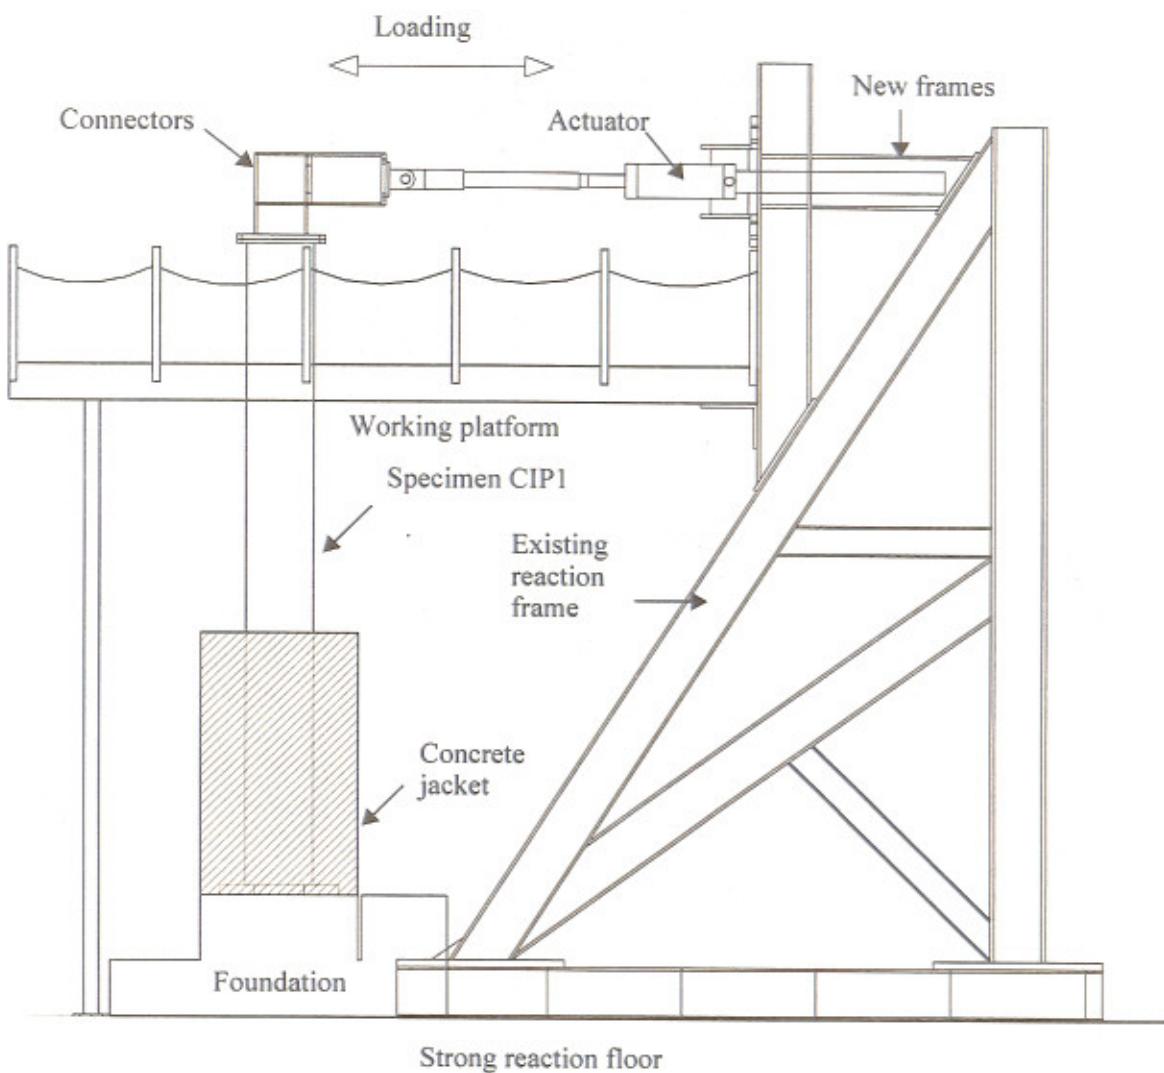
Figure 3.4: Main components of the test setup for Specimen CIP1

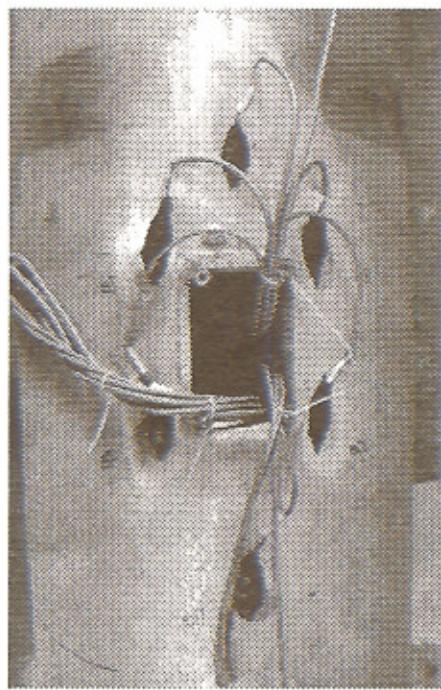
Figure 3.5: Instrumentation of Specimen CIP1

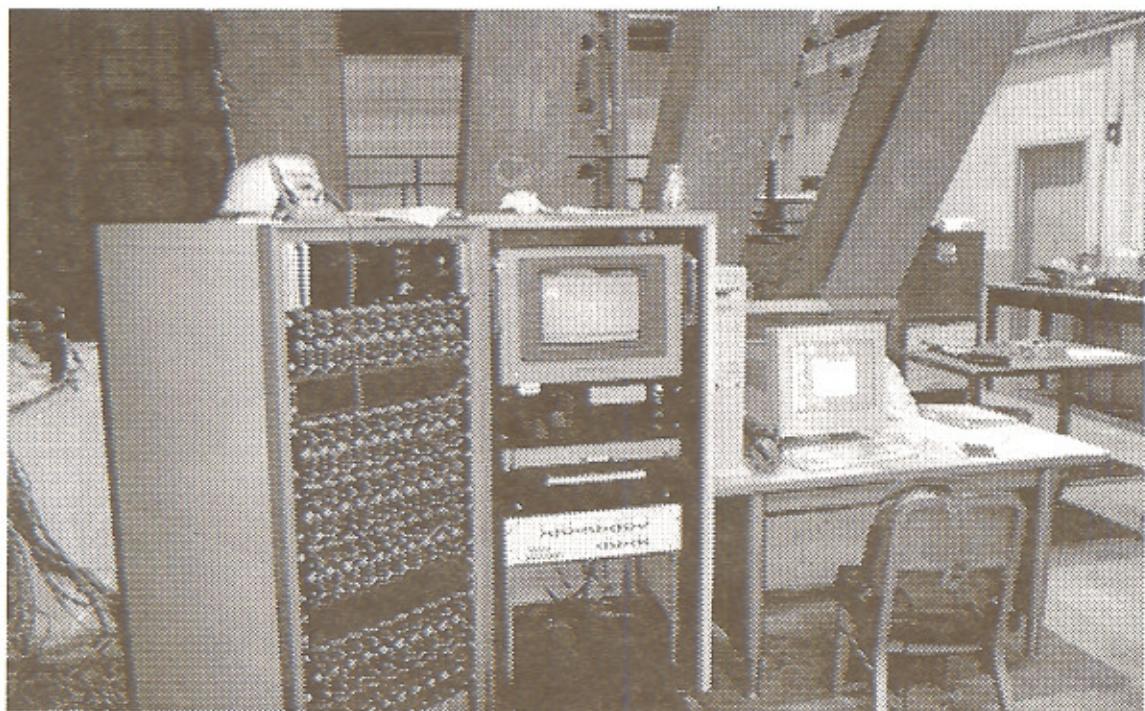
Figure 3.6: View of the data acquisition system

Other data was monitored and recorded using an AutoNet data acquisition system with a capacity of 64 channels. Pacific signal conditioners were used to amplify the transducer signals and to remove frequencies above 100 Hz from the analog signal.

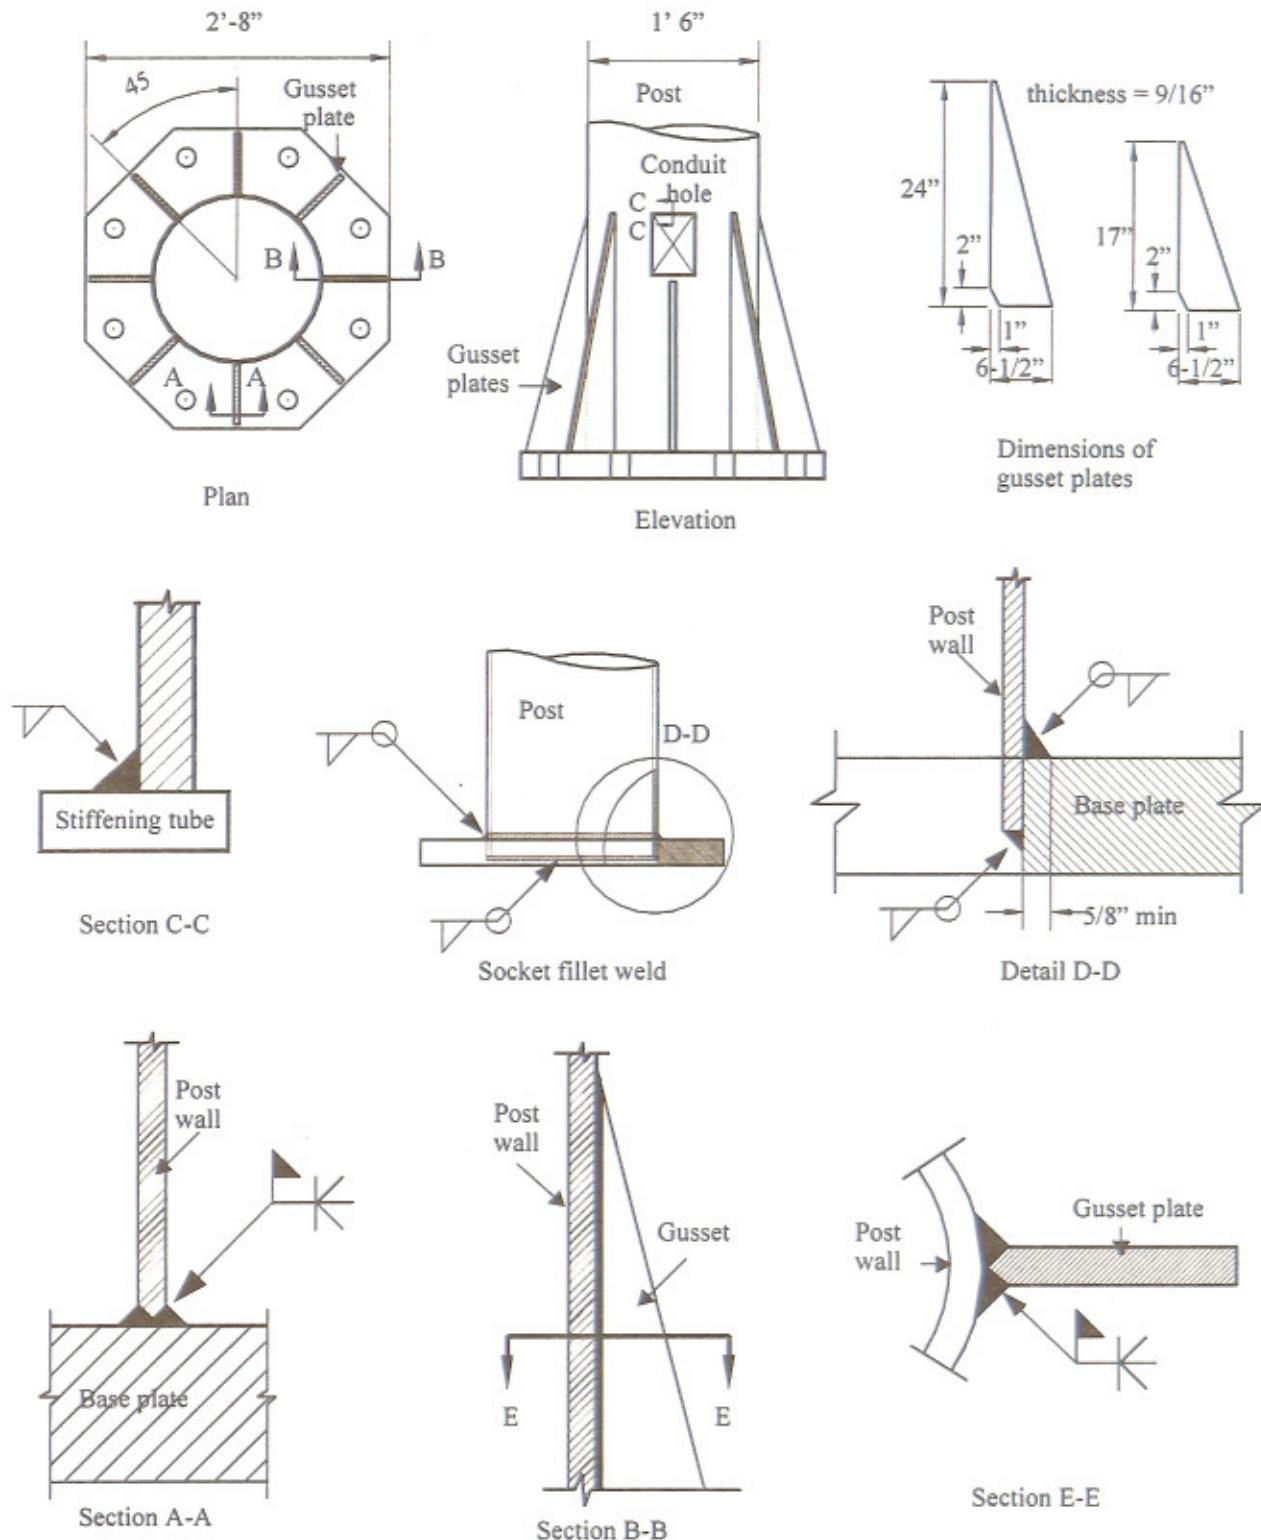
Figure 4.1: Dimensions and connection details for gusset-retrofit Specimen GR1

The test specimen was fabricated by cutting a CMS post with an outside diameter of 18 in. (457 mm) and a wall thickness of 1/2 in. (13 mm) to a length of 14 ft. 4 in. (4.4 m) to accommodate the framing built for testing of other CMS components (Gilani, et al., 1997). The post was socket fillet welded at its base (see Figure 4.1) to a 2-3/4 in. (70 mm) thick octagonal steel plate. The specimen was connected to the foundation using eight 2-1/4 in. (57 mm) diameter anchor bolts following Caltrans guidelines. The upper nuts were first snug tightened, then further tightened by the turn-of-the-nut method (AISC, 1995). A

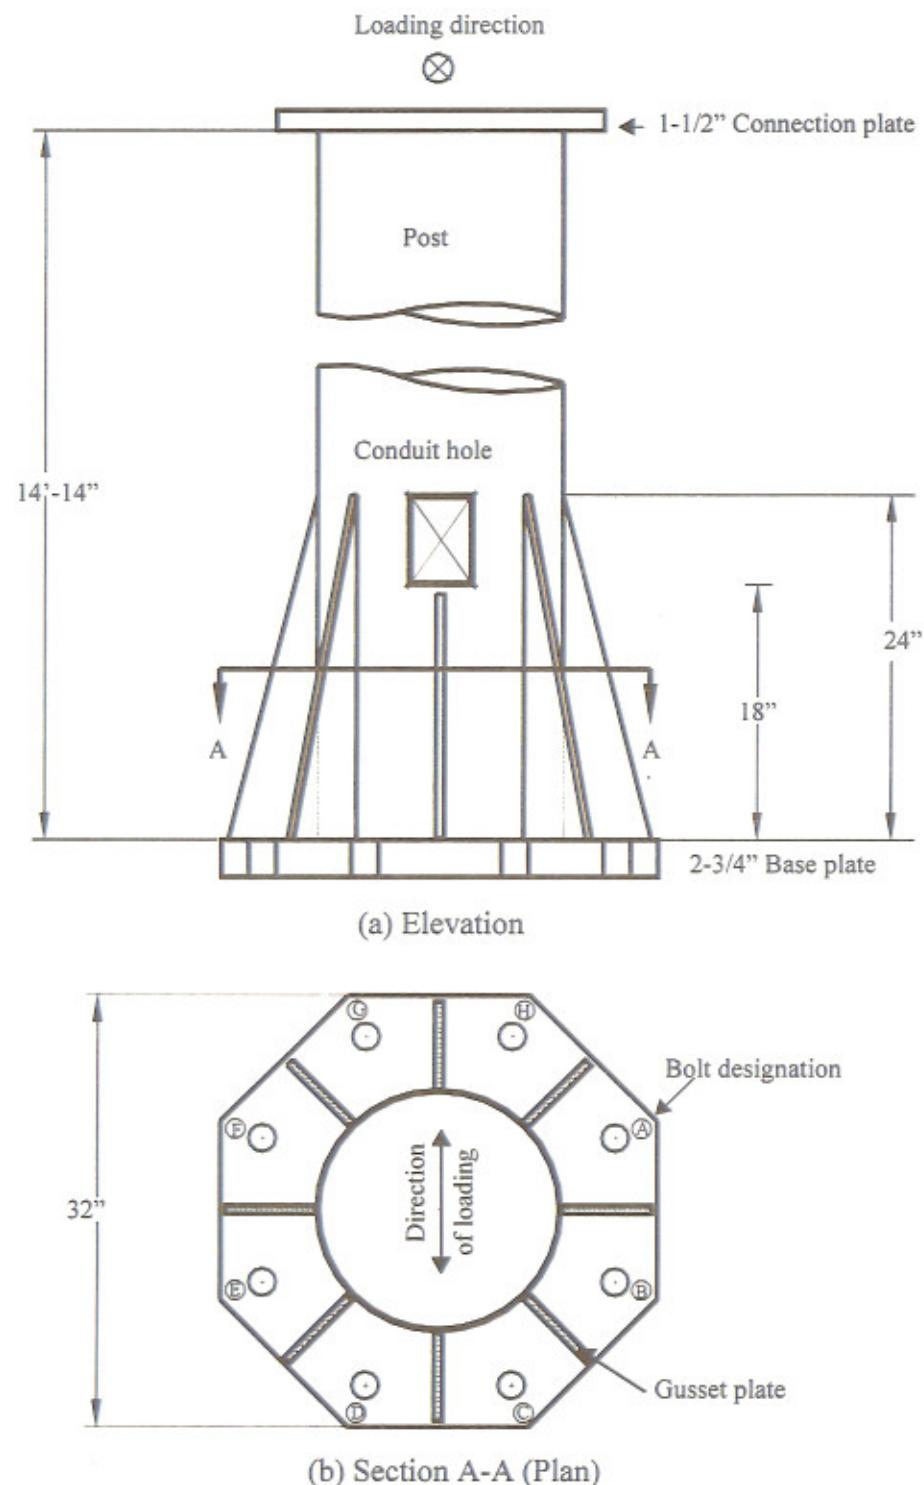
Figure 4.2: Schematics of setup for Specimen GR1

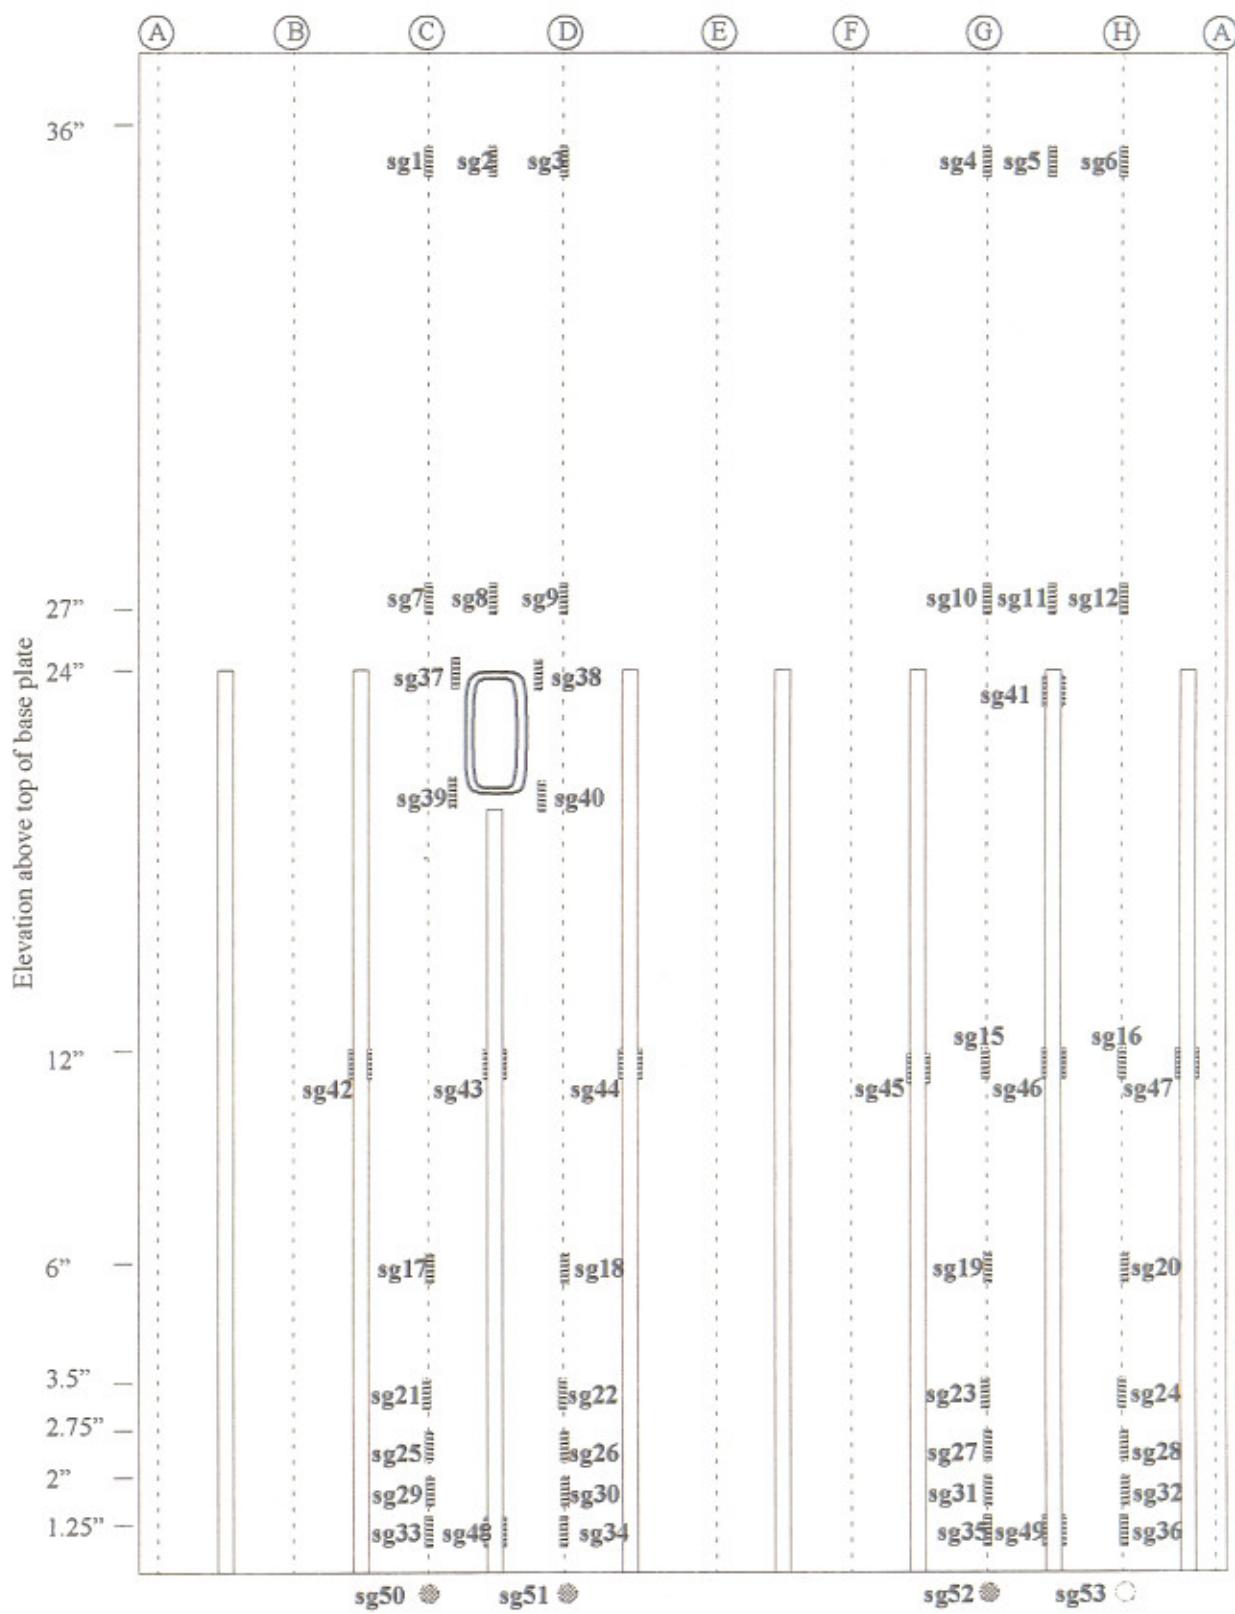
Figure 4.3: Instrumentation for Specimen GR1

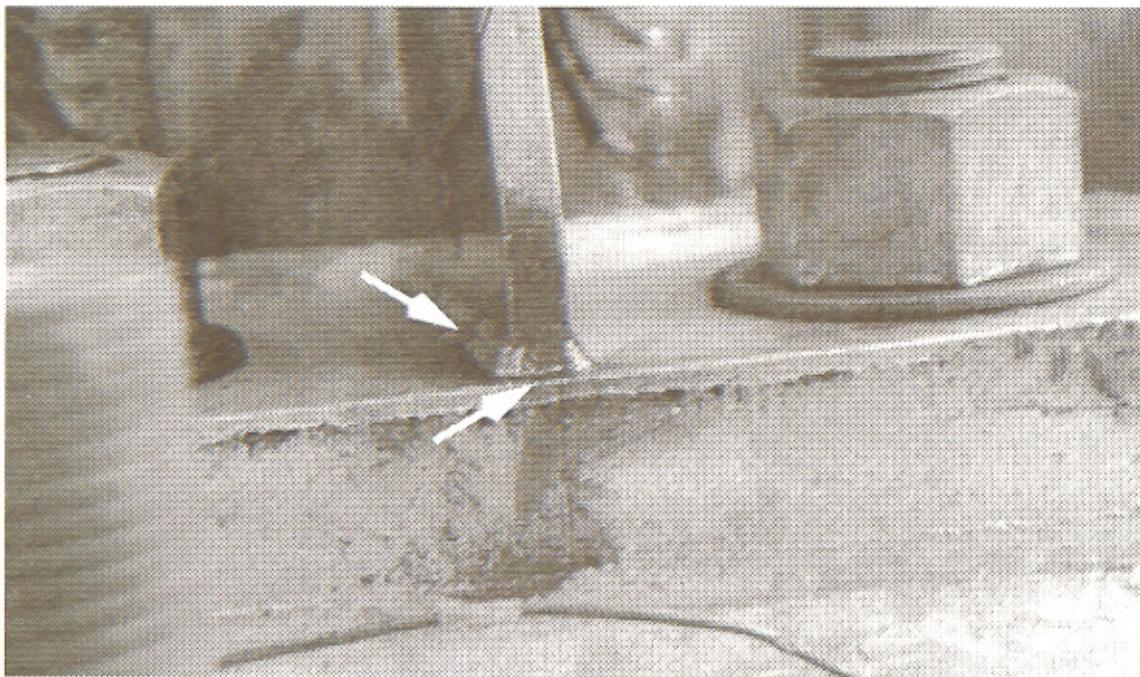
Figure 4.4: Cracking of gusset-to-base plate weld for Specimen GR1

Several cracks were identified during cyclic testing, including cracks in the gusset-to-base plate welded connections, the gusset-to-post welded connection, the gusset-to-base plate welded connections, the post-to-base plate welded connections, the gusset parent metal, and in the post initiating at the upper and lower corners of the conduit hole. Figures 4.4 and 4.5 identify the cracks observed at the gusset-to-base plate connection and at the conduit hole at the end of the testing.

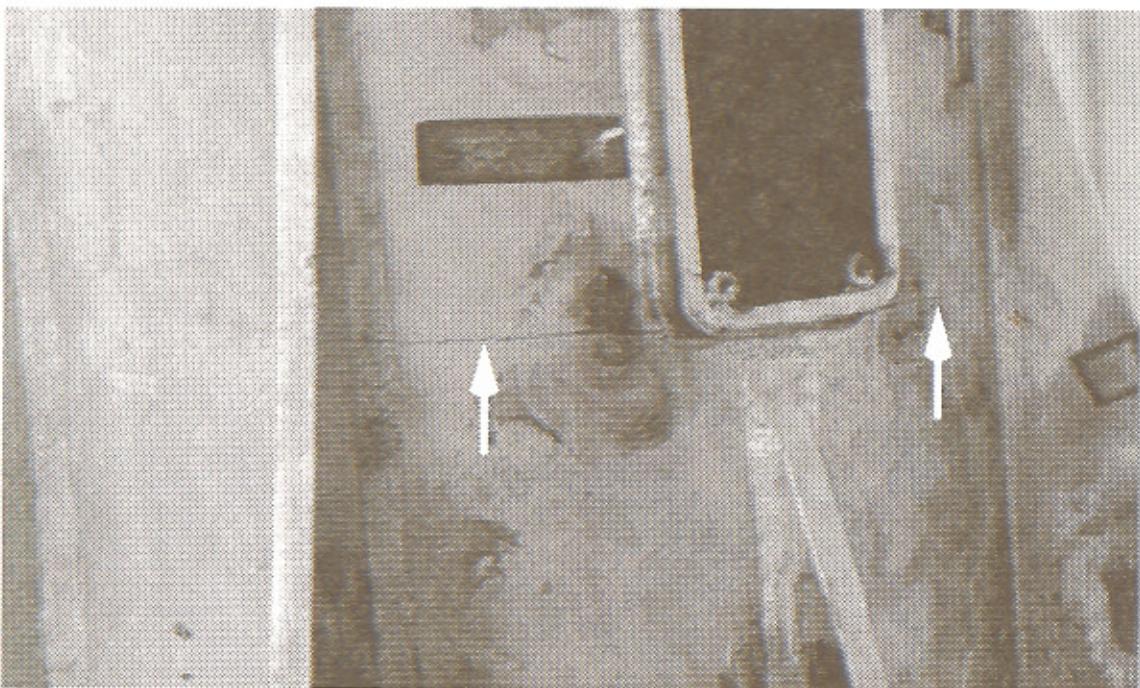
Figure 4.5: Crack propagation at the conduit hole for Specimen GR1

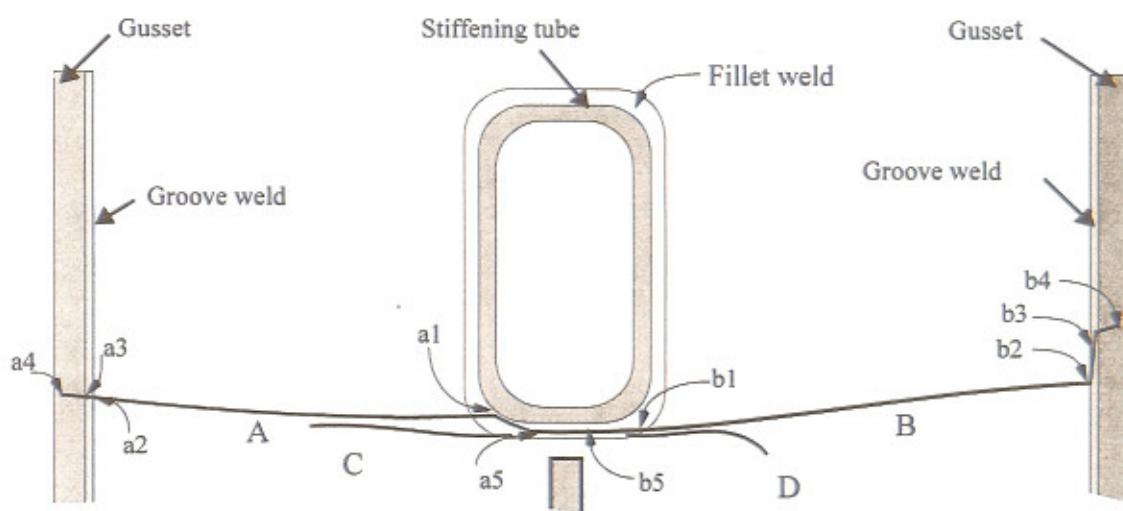
Figure 4.6: Crack pattern around the conduit hole for Specimen GR1

Figure 4.6 shows the crack pattern around the conduit hole. In particular, two horizontal cracks initiating at the lower left (a1) and right (b1) corners of the conduit hole (designated as cracks A and B, respectively) propagated substantially as the cycles accumulated. These cracks reached the gusset-to-post welded connections (a2 and b2) at approximately 985,000 cycles.

Crack A, starting at the lower left corner of the conduit hole (a1), propagated horizontally toward the gusset-plate groove weld (a2), passed through this weld (a3) at 1,020,000 cycles, and then propagated into the gusset parent metal (a4) at 1,055,000 cycles. Crack B, starting at the lower right corner of the conduit hole (b1), propagated to the gusset-plate groove weld (b2), through the gusset plate-to-post weld (b3) at 1,020,000 cycles, and then into the gusset parent metal (b4) at 1,055,000 cycles. Both cracks continued to propagate into the gusset parent metal. In addition, due to the propagation of crack A to the right (a5) and crack B to the left (b5) at the conduit hole, these cracks met below the bottom edge of the conduit hole at approximately 860,000 cycles.

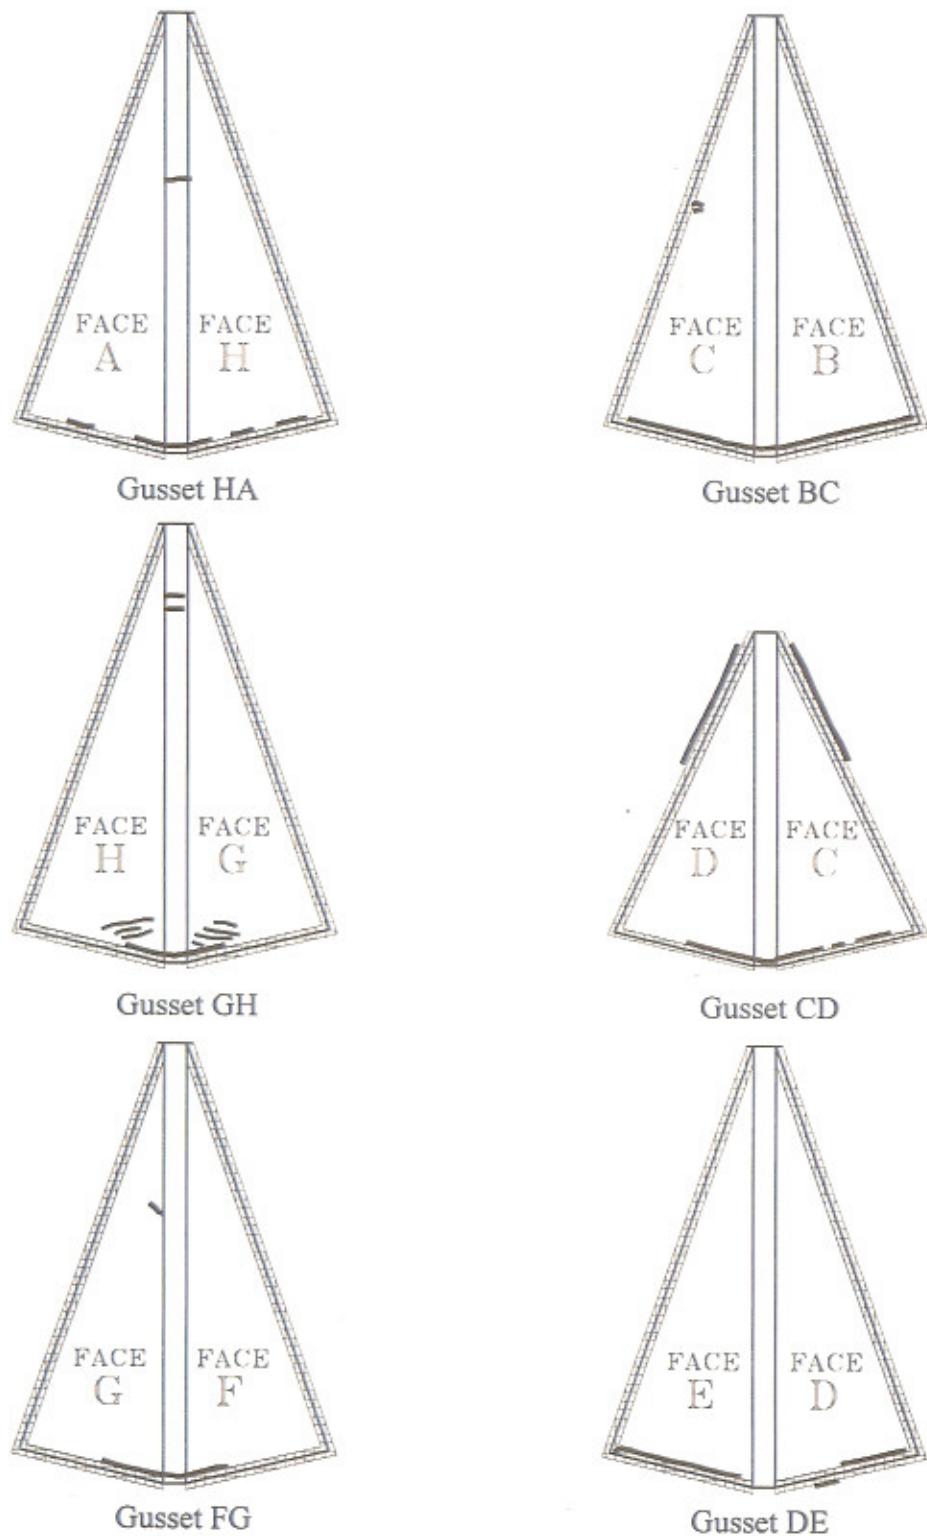
Figure 4.7: Cracking (solid heavy line) in the gusset plates (shown in exploded view) of Specimen GR1

Figure 4.7 shows the locations of the cracks (solid heavy line) in, and adjacent to, the gusset plates at the conclusion of the cyclic test. Most of the cracks developed in the gusset plate-to-base plate welded connections. Cracks also developed at the gusset plate-to-post connection in gusset CD (tension side) below the conduit hole.
